REPORT

HCL 69/00	Accident		
Aircraft Type:	Socata TB 10	Aircraft Registration:	D-EACQ
Engine(s):	Lycoming O-360-A1AD	Type of flight:	Private, VFR
Crew:	1 - Fatal	Passagers:	2 - Fatal
Place:	South of Skovmose on Als	Date and time:	29.11.2000, 1713 UTC

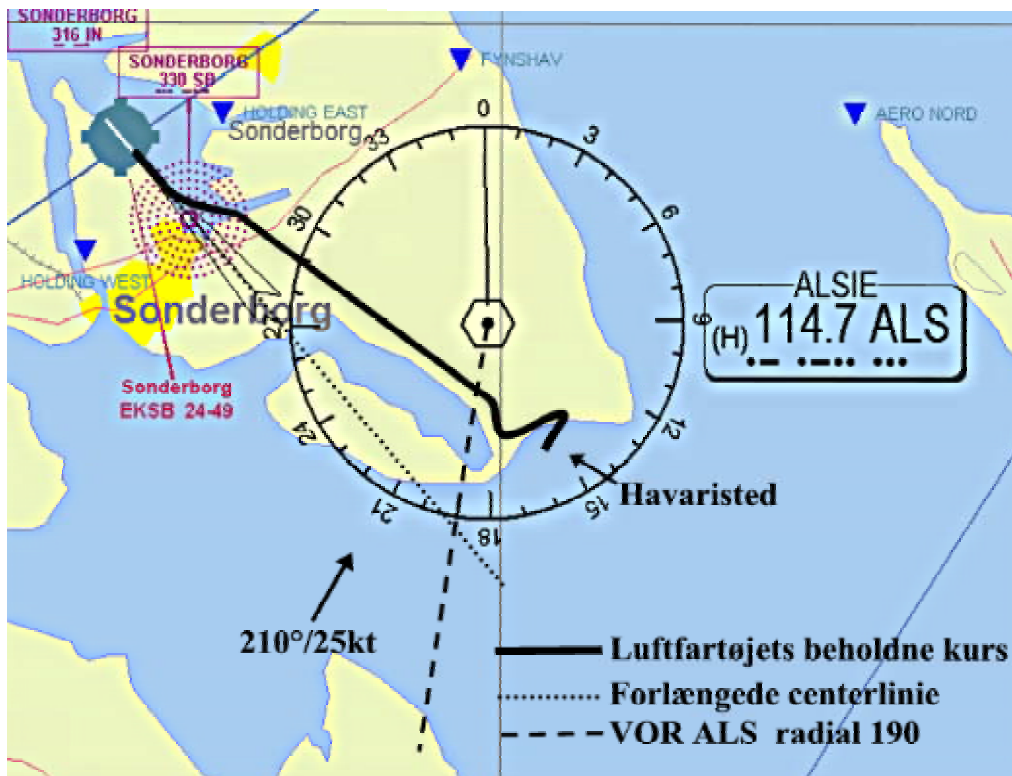
Appendix D: The aircraft track.

The aircraft track is displayed in appendix D.
