REPORT

HCL 69/00	Accident		
Aircraft Type:	Socata TB 10	Aircraft Registration:	D-EACQ
Engine(s):	Lycoming O-360-A1AD	Type of flight:	Private, VFR
Crew:	1 - Fatal	Passagers:	2 - Fatal
Place:	South of Skovmose on Als	Date and time:	29.11.2000, 1713 UTC

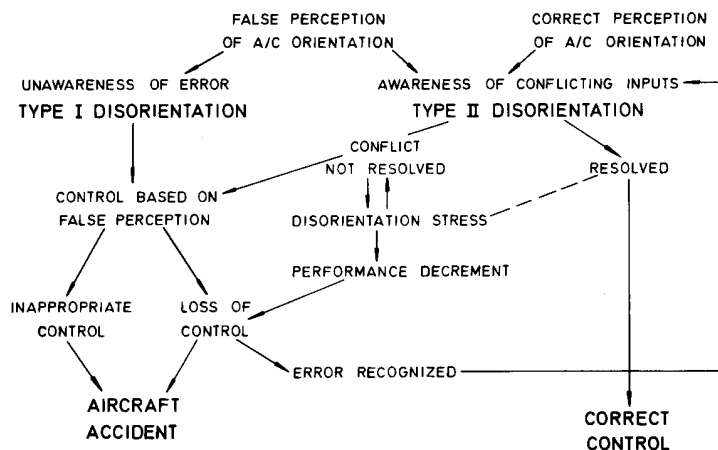
Figure 20.1 – Diagrammatic representation of how Types I and II disorientation can affect the pilot's control of the aircraft.

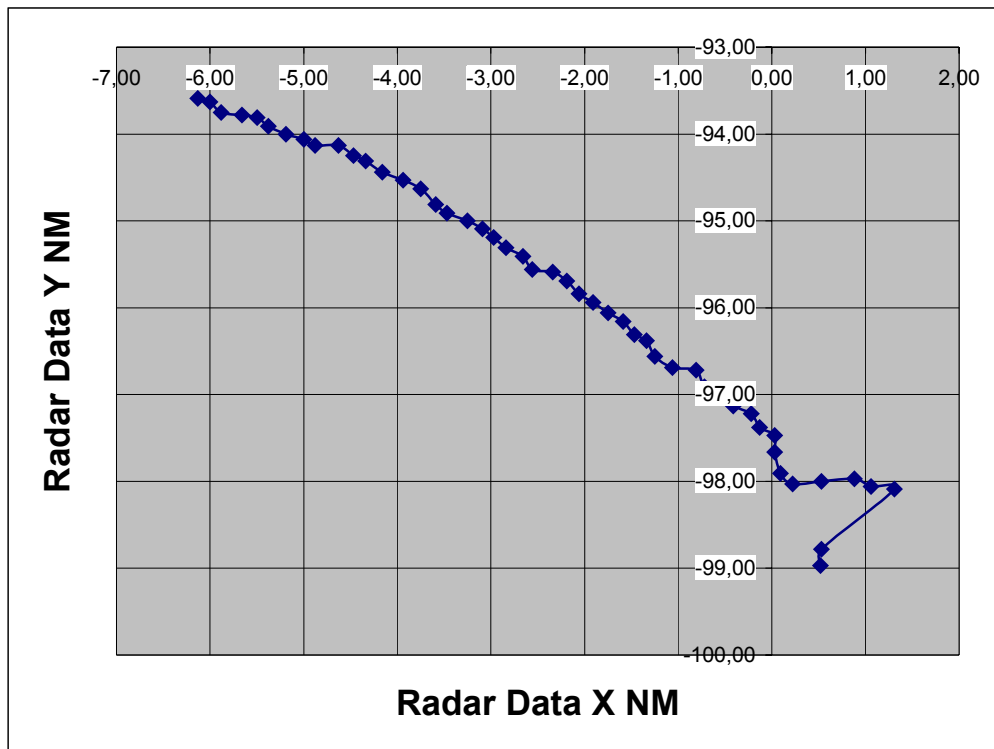
Appendix B: Radar data. 1 unit = 1 nm.

Between 17:07:07 hrs and 17:08:05 hrs the average was TT $113,3^{\circ} \pm 18,6^{\circ}$
between 17:08:05 hrs and 17:09:07 hrs the average was TT $118,3^{\circ} \pm 24,2^{\circ}$
between 17:09:07 hrs and 17:10:04 hrs the average was TT $127,0^{\circ} \pm 17,1^{\circ}$
between 17:10:04 hrs and 17:11:07 hrs the average was TT $124,1^{\circ} \pm 21,8^{\circ}$
between 17:11:07 hrs and 17:12:04 hrs the average was TT $127,9^{\circ} \pm 29,0^{\circ}$
between 17:12:04 hrs and 17:13:07 hrs the average was TT $129,4^{\circ} \pm 47,8^{\circ}$ and
between 17:13:07 hrs and 17:13:23 hrs the average was TT $169,4^{\circ} \pm 65,9^{\circ}$.
